The Spartan Cap Athletic Field System

Alec Kowalewski

Environmental Horticulture
Abraham Baldwin Agricultural College
Tifton, GA

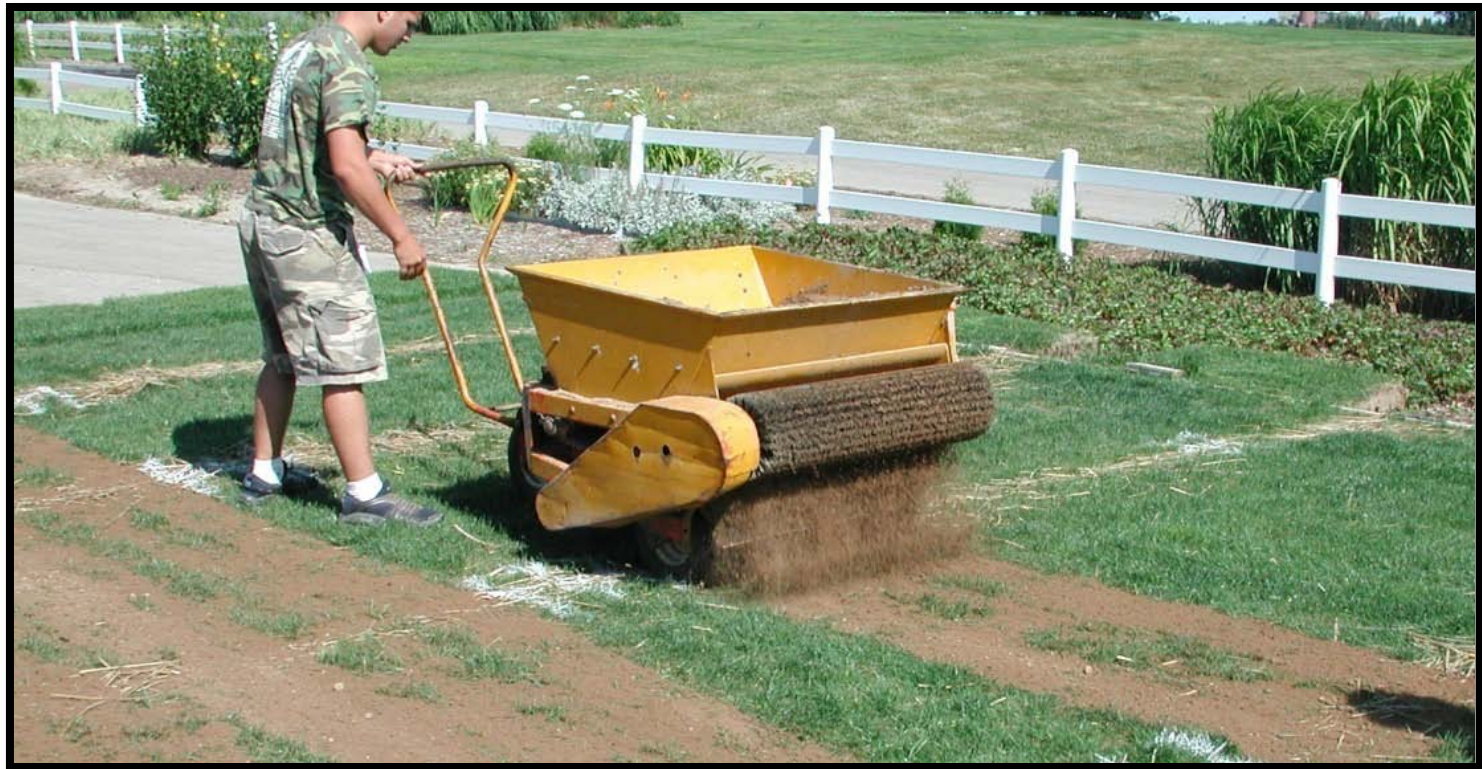
2007 Results

- Shoot density
- Turf shear tester strength

- 0.5 inch of topdressing, applied over a 5-week period, provided the greatest turf shear tester strength in the fall of 2007 and 2008.
- All cumulative topdressing application rates improved turfgrass shoot density in the fall of 2008.
- Summer traffic was not detrimental to fall turfgrass shoot density or turf shear tester strength.

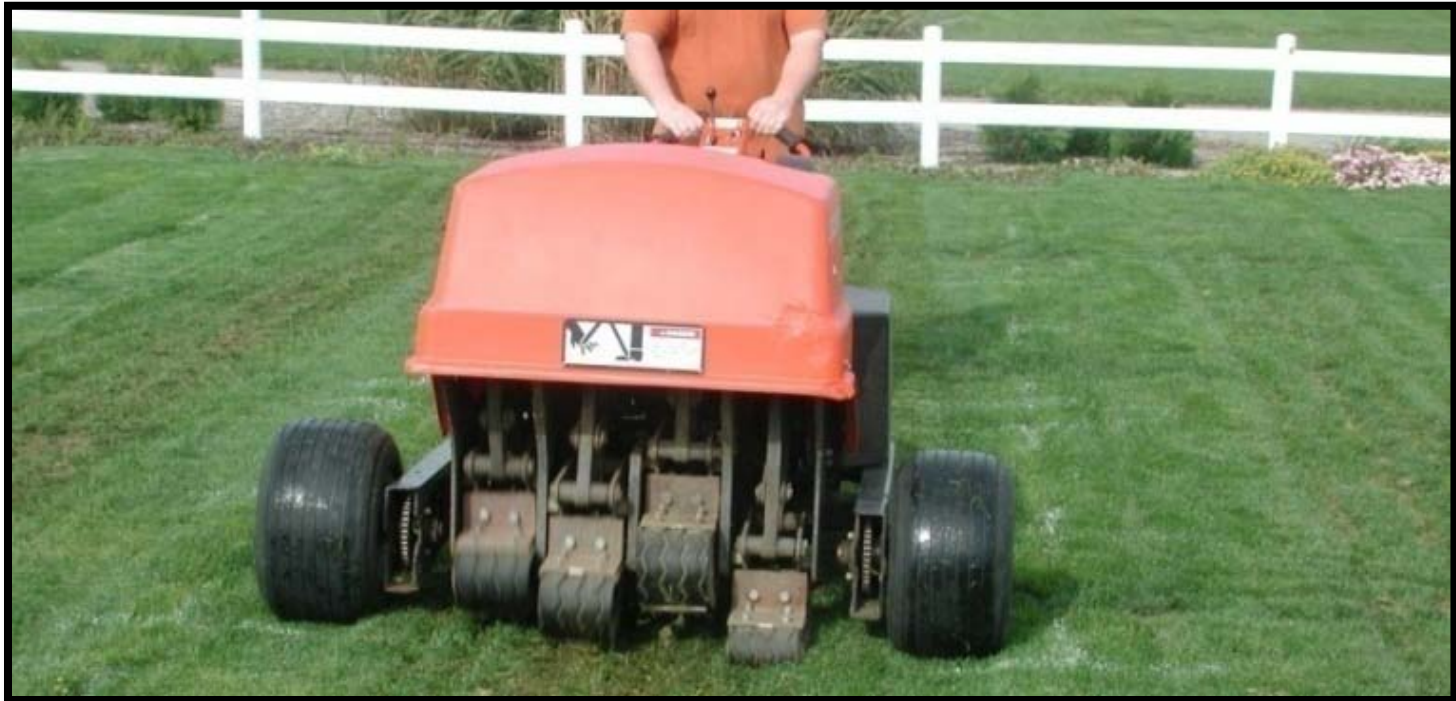
Materials and Methods

- Fall traffic (Oct. 14 – Nov. 12, 2008)
 - 4 passes/week

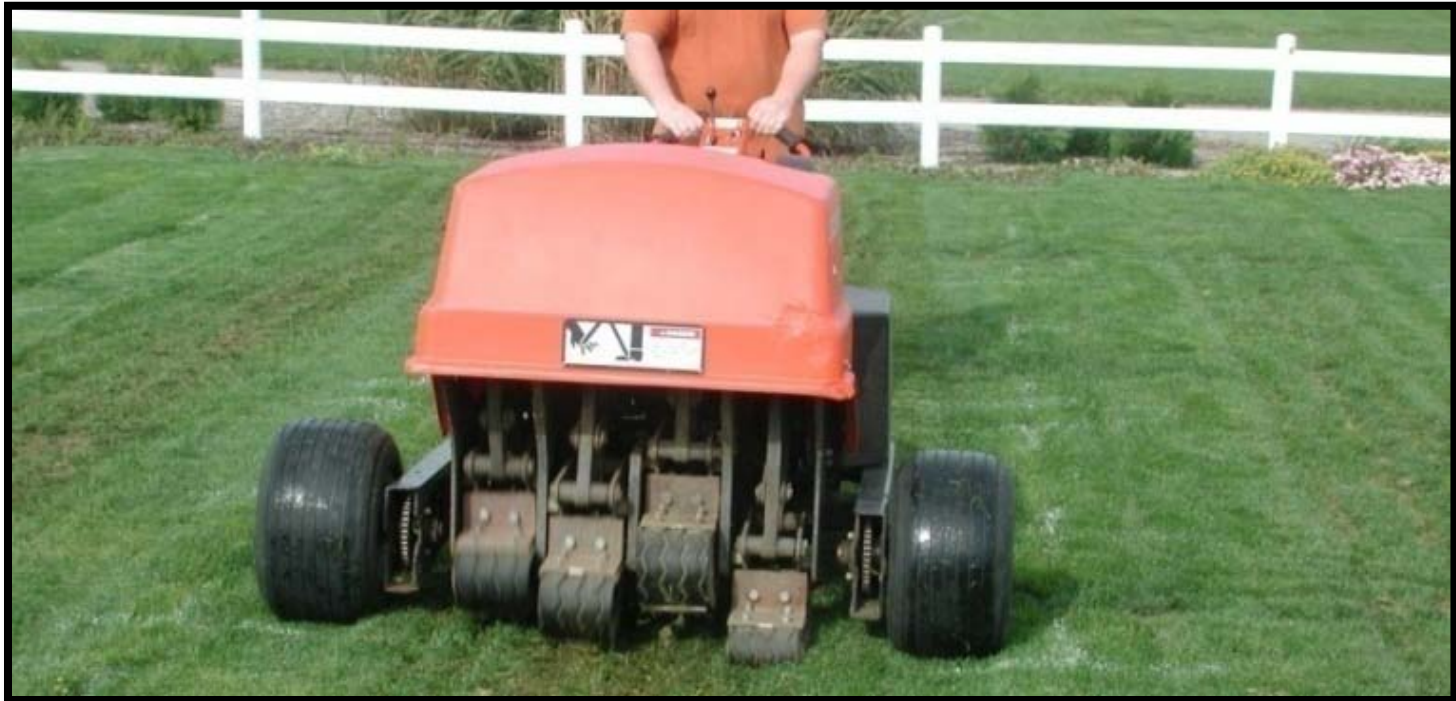
Materials and Methods

- Fall traffic (Oct. 14 – Nov. 12, 2008)
 - 4 passes/week

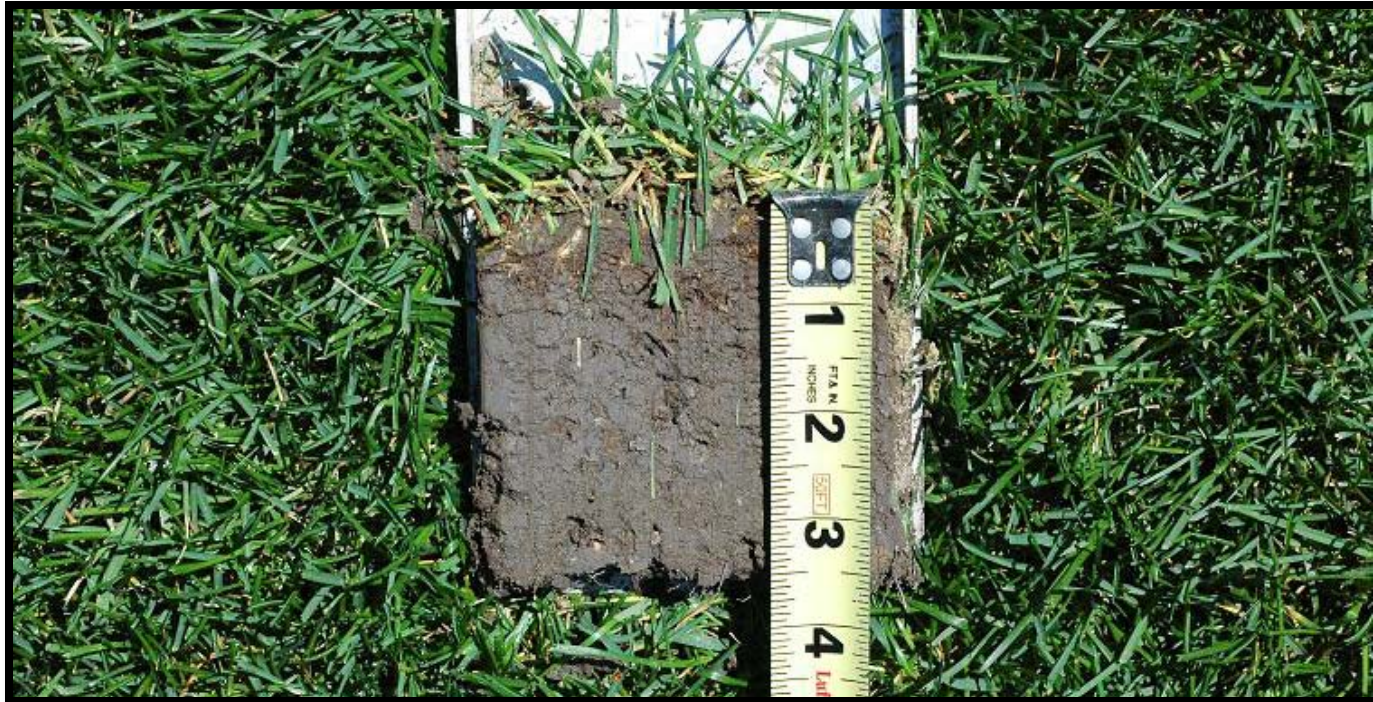
Materials and Methods

- Control
 - No topdressing

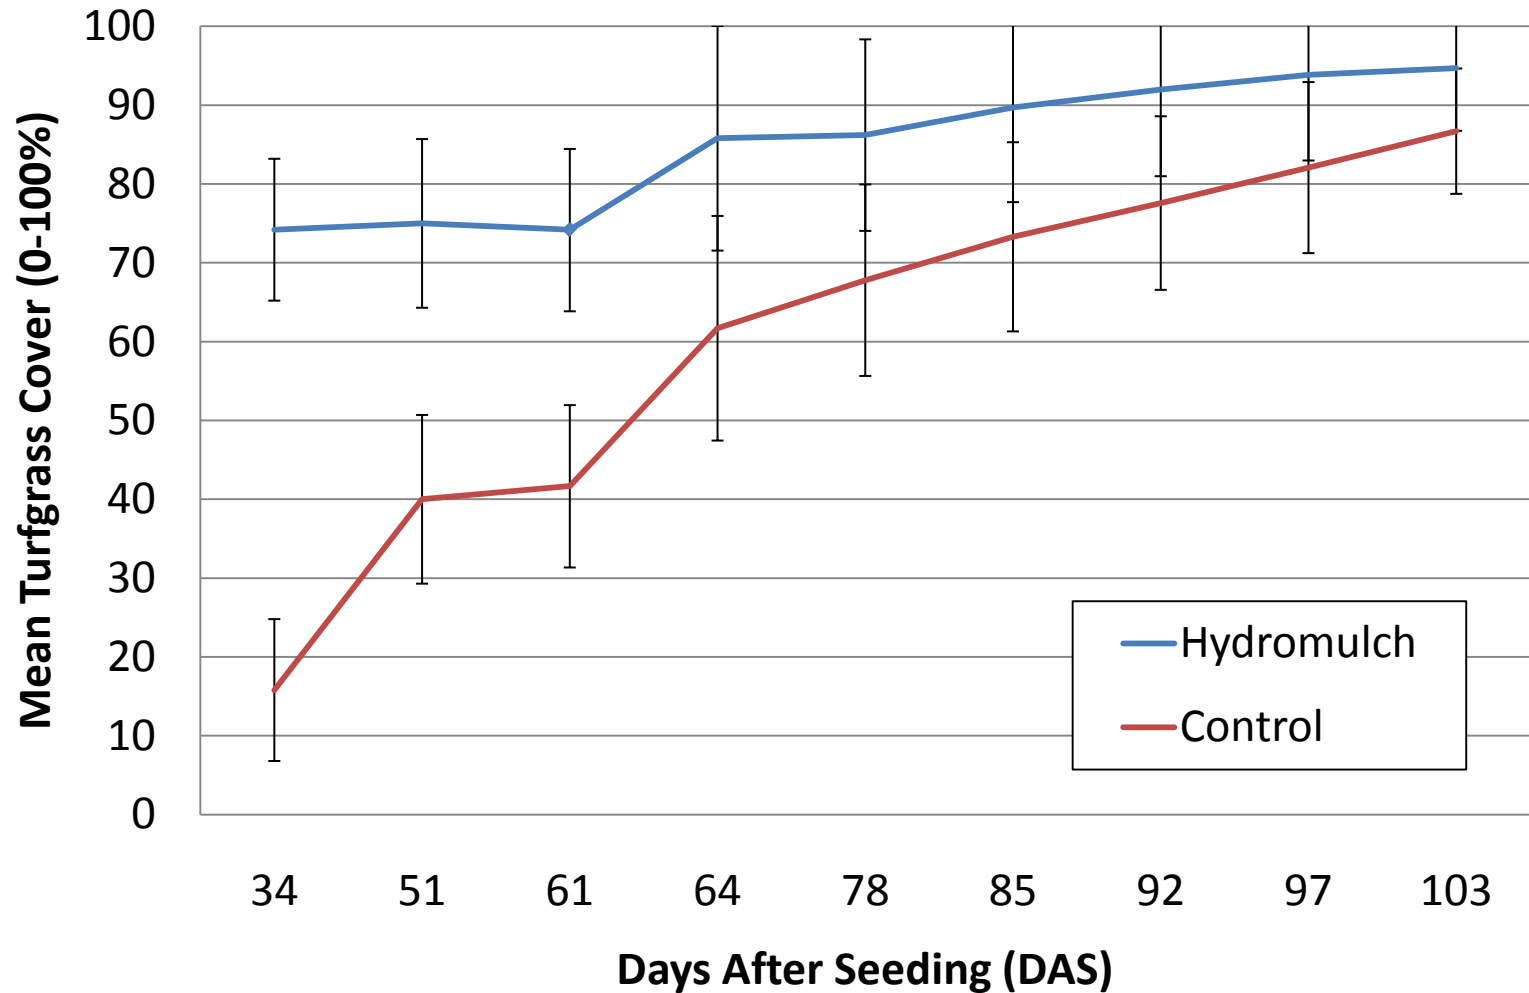
Effects of seeding mulch on Kentucky bluegrass establishment from seed over sand filled intercept drain lines, renovated May 26, 2010.

Means values with overlapping error bars are not significantly different according to LSD (0.05).

- If field use will begin sooner than 64 days following renovation then...
 - Seeding mulch can provide substantially greater turfgrass cover over recently renovated Intercept drain lines
 - Seeding mulch
 - \$??/50 lbs
 - 50 lbs/1,000 ft²
 - Intercept drain tile spacing
 - 13 ft/3,000 ft²
 - \$???

- If field use will begin 64 days after renovation or later...
 - Benefits of seeding mulch are no longer significant
