## Successful Solutions for Failed Fields

Norman W. Hummel  
Hummel & Co Inc.

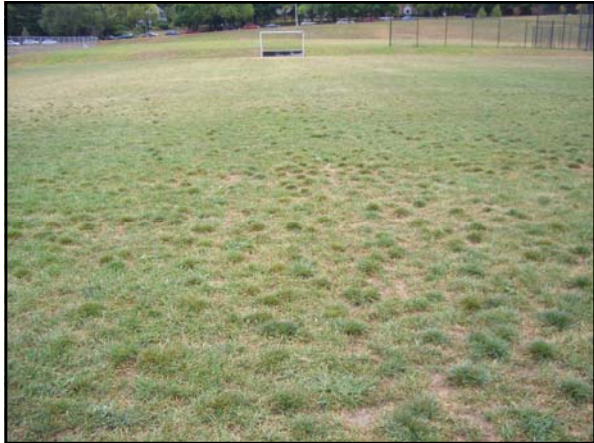
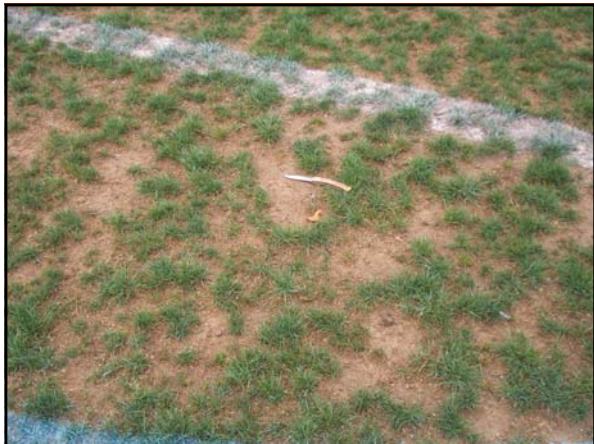
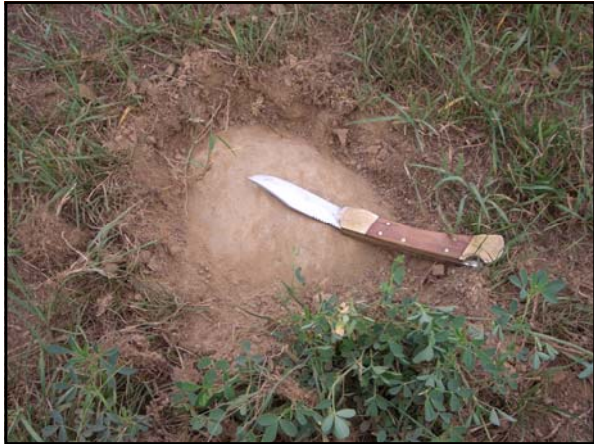
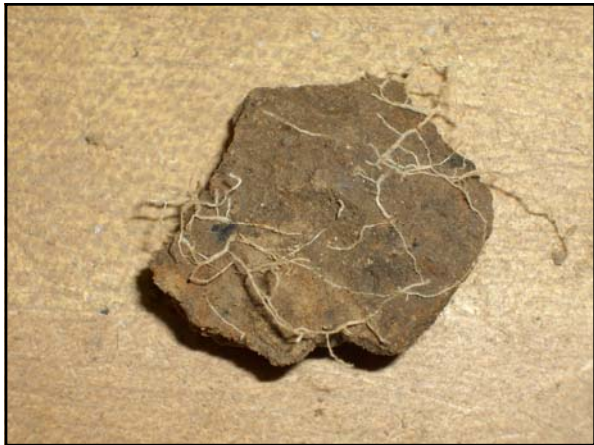
### Case #1 You Can Pay Me Now or ....

- Three year old soil based fields
- Money for soil improvement removed from budget
- Never had good stand establishment
- Field is hard
- Rocks keep surfacing
- Maintenance adequate
- Shut down fields

- Turf – predominately perennial ryegrass, poor stand, bluegrass in mix failed
- Soil – fine textured, low organic matter, extremely compacted, very rocky, poor quality

- Program of overseeding, conventional aeration, deep tine aeration, topdressing
- Plow field, rock hound, amend with properly sized sand, compost, reestablish

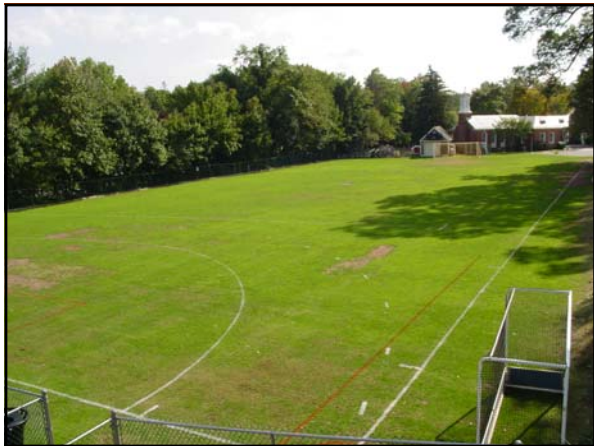
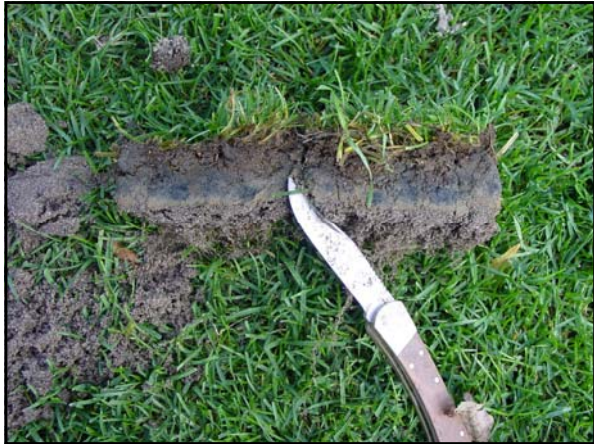
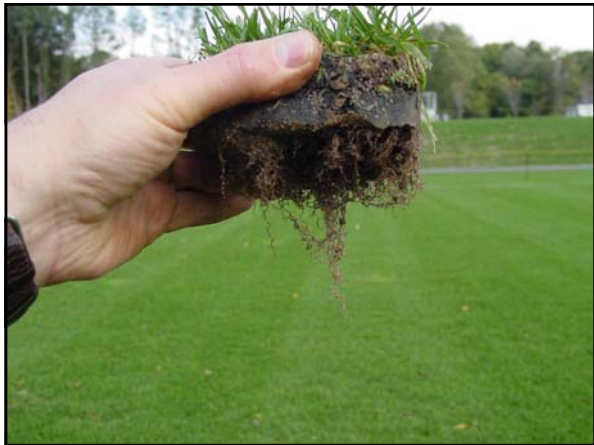
### Case #2 It was beautiful until we started using it

- 1 year old sand based field
- Sand grown sod
- Poor rooting
- Poor wear tolerance

- Everything was done right, except:
  - Did not start on aerification and/or topdressing program
  - Overwatering

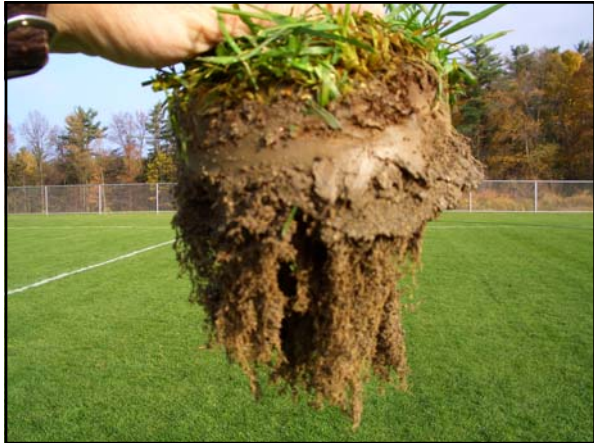
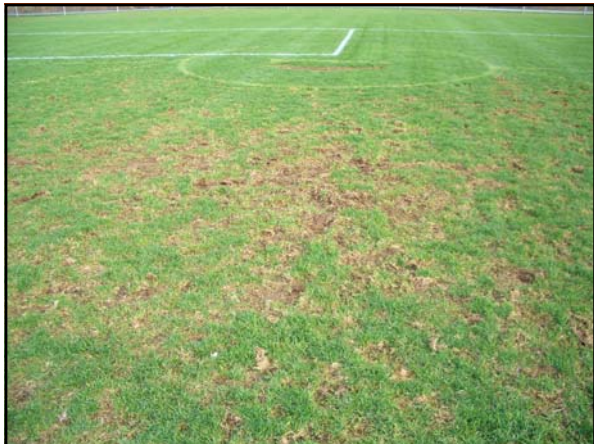
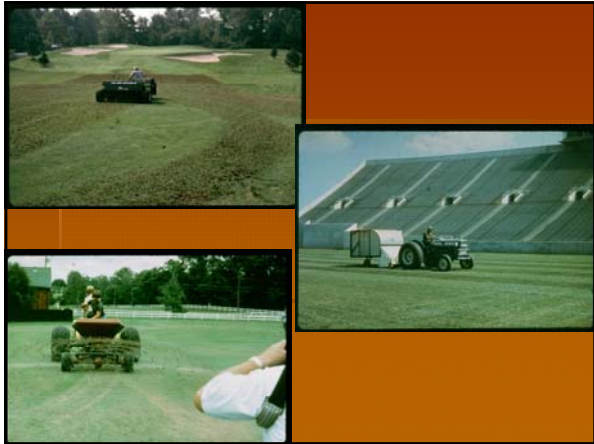
### Case #3 Dispelling an old myth

- Sand capped field
- Sod grown on silt loam soil
- Divoting, slippery surface

- Sodded fields – start on regular aerification program to plug out sod layer as soon as sod can tolerate. If sod is grown on soil, harvest cores if possible.

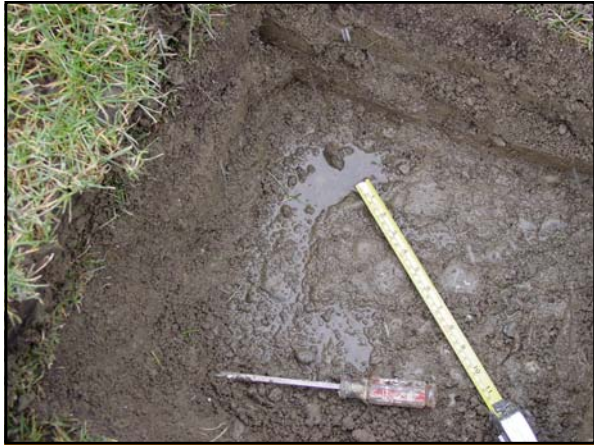
### Sub-Surface Drainage System

- Needed when there is presence of a water table in close proximity to soil surface.
- Needed when sub-soil is considerably less permeable than topsoil
- Will not correct surface drainage problems

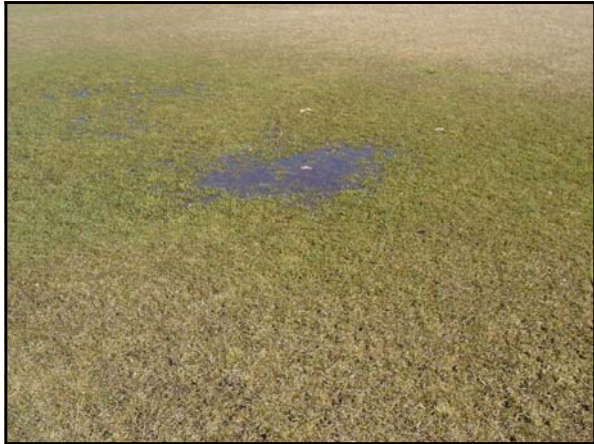
### Surface Drainage

- Provide adequate pitch or slope to soil based fields (> 1.5%)
- Try to keep spans under 200 ft.
- If pitch not possible, consider by-pass drainage

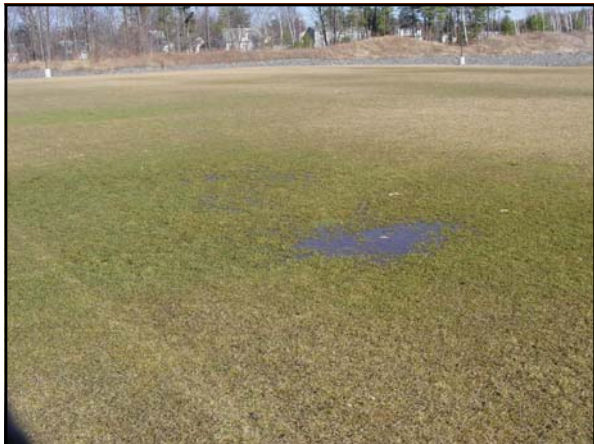
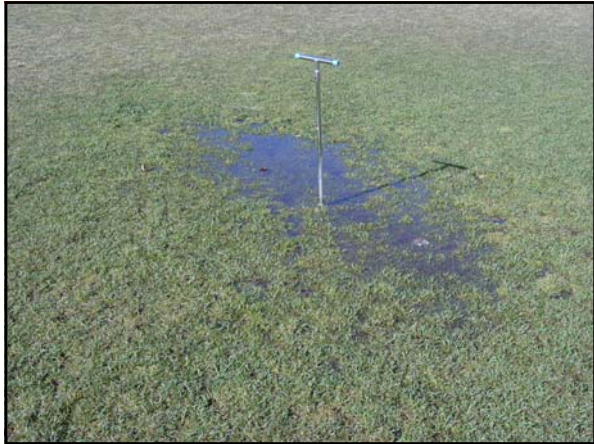
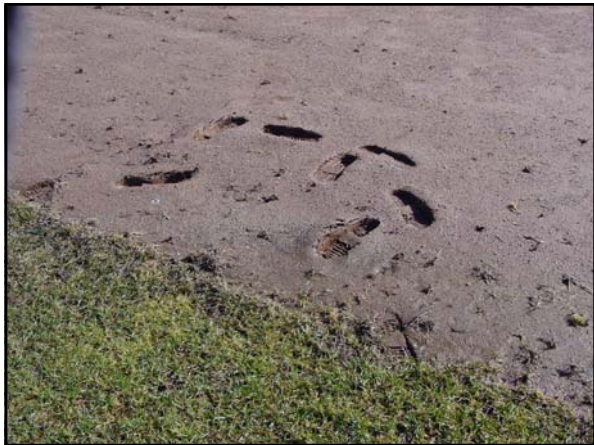
**Case #4: One percent is not enough**

- New soil based fields failing
- Poor drainage, one field unusable
- Good turfgrass stand establishment
- Fields built with 0.75% slope, long runs
- Very compacted subsoils

- Fields built too flat
- Rock Ledge, no subsurface drainage system
- Fine textured soil. Silt loam was specified, sandy loam was used.
- Soil was extremely compacted, especially below 6 inches.
- Found out Caterpillar road scraper used for soil placement and grading

- Rebuild fields
- Compaction – core cultivation, Howard Earth Quaker, Aerway Shattertine
- Drainage – bypass drainage system

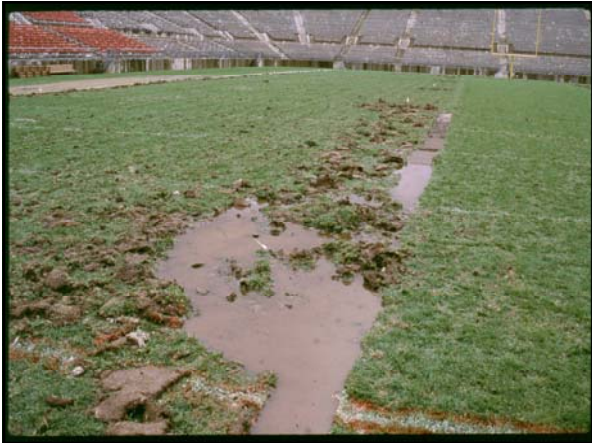
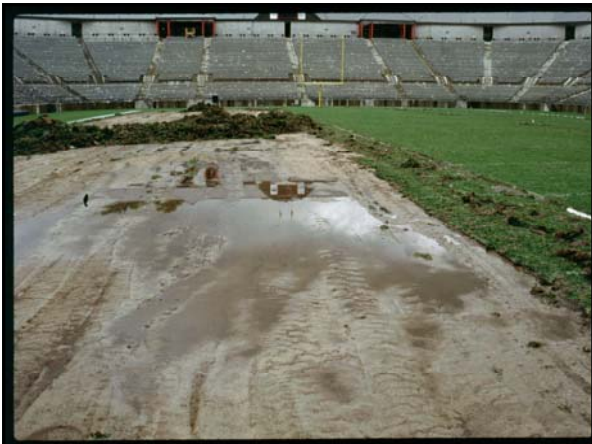
### Case #5 - One Failure Isn't Enough

- Three sand based fields built at same time (football stadium, lacrosse/soccer, track and field)
- All failing, poor drainage

- Poor root zone specifications
  - Did not define performance parameters
  - Vague in terms of particle size requirements (specified 75-25 sand to soil)
  - No quality control testing
- Contractor was inexperienced – did not recognize problem with specifications

- Client did not get what they paid for – rebuild the field
- Seven figure settlement reached in mediation
- Two fields were rebuilt

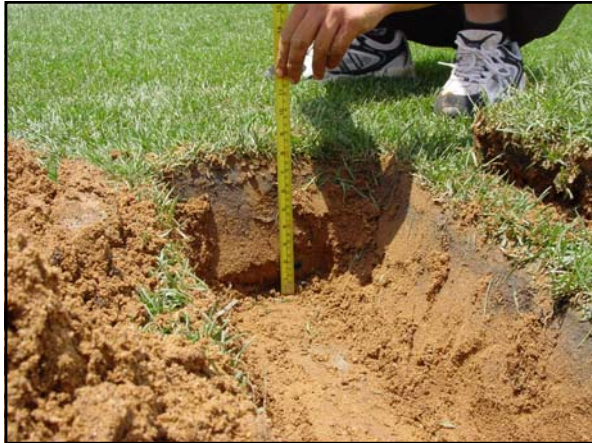
## Case #6 – This Field Stinks or It’s Amazing What Sod Will Hide

- 6 month old sand capped field
- Complaint of poor drainage, standing water, wet conditions on turf area
- Field smelled septic
- Turf in good condition

- Reconstruct
- By-pass drainage system
- Use of wetting agents
- Deep tine aeration

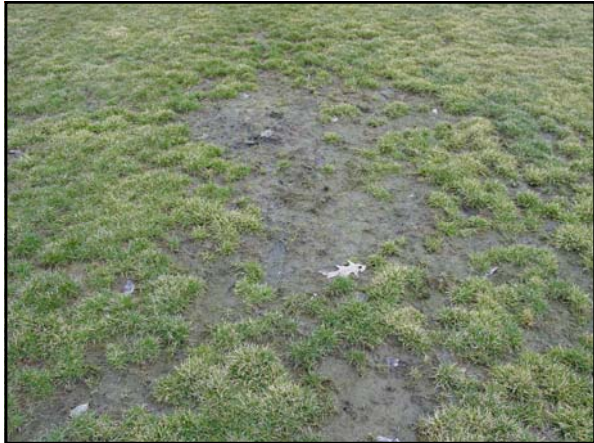
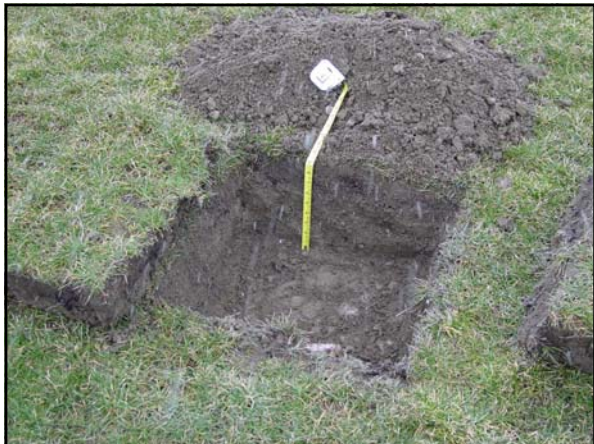
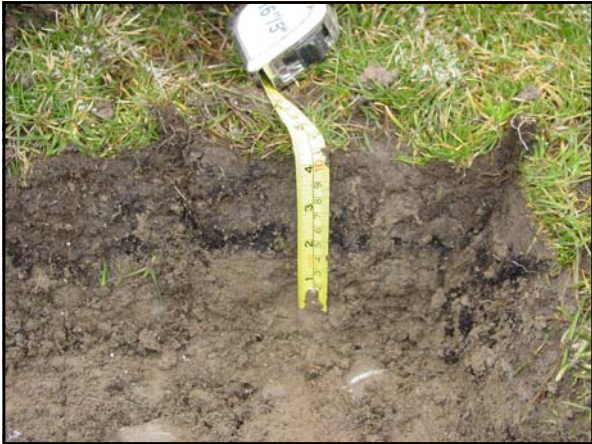
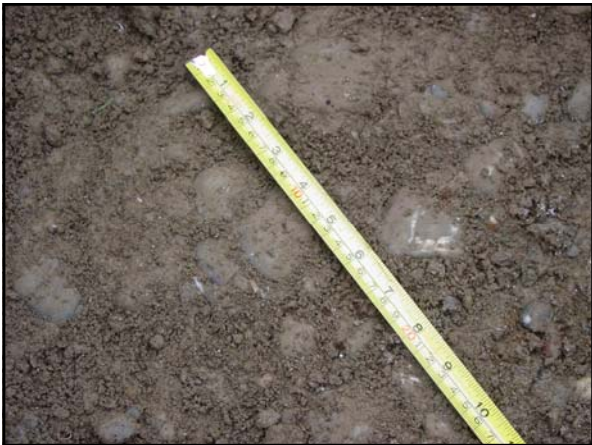
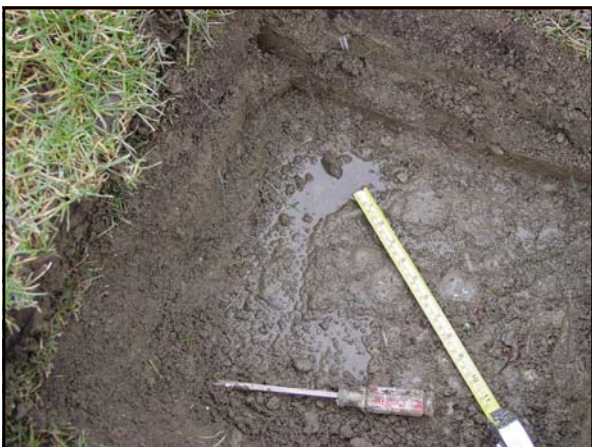
### Case #7 Six Months Later, the Field Never Drains

- 6 year old soil based field
- About 1% crown, flat in center
- Silt loam soils
- Drained well first six months, has been bad ever since despite extensive under drainage system
- Opposing teams now refusing to play on field

- Fine textured soils, inadequate surface drainage
- Field flat in center of field
- Severely compacted and poorly graded sub-grade entombing drainage system. Possible soil migration into stone.
- All a result of poor design and design flaws

- Remove sod in center of field, rebuild crown (used amended soil), resodded
- Installed bypass drainage system
- Rebuild field was option but was not selected.

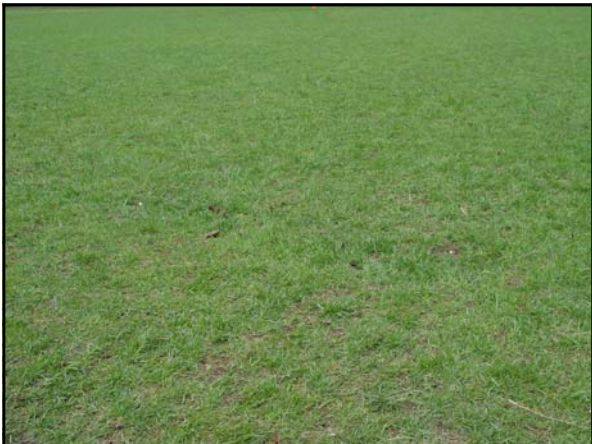
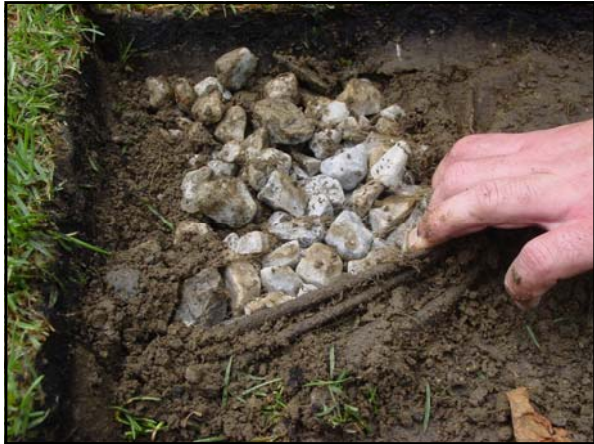
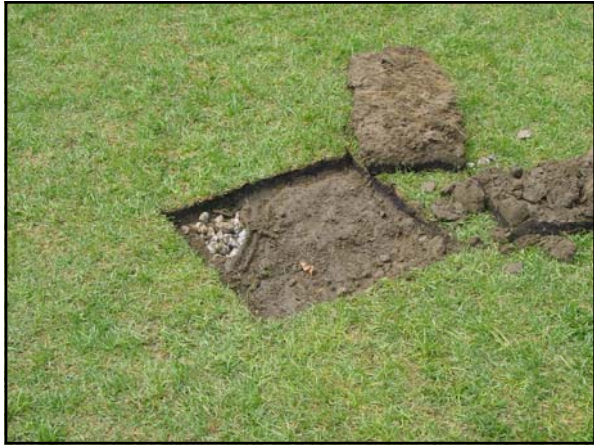
### Case #8 Something's missing

- 1 year old soil based field
- Extensive under drainage system
- Geotextile fabric separating soil from gravel
- Field performing poorly
- Good maintenance program

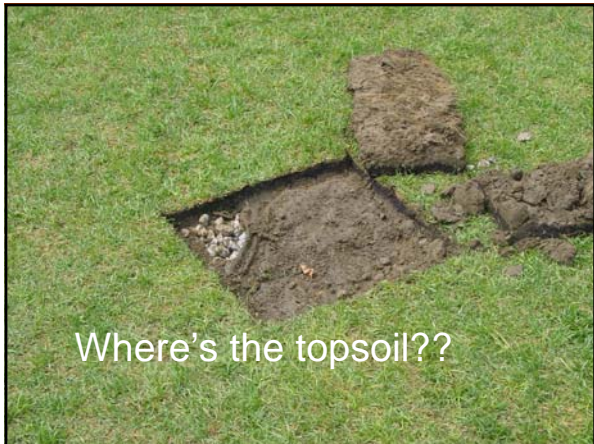
Where's the topsoil??
